Thermal and mechanical abuse of electric vehicle pouch cell modules

This paper reports thermal (burner) and mechanical (blunt trauma and nail penetration) abuse experiments on electric vehicle lithium ion modules comprising eight 56.3Ah lithium nickel manganese cobalt (NMC) pouch cells. The aim of project part of which is described in this paper was to study the problem of thermal runaway in lithium ion batteries under different abuse conditions and at different SOC and to bridge the current gap in the literature between cell level studies and research at pack and system level. These experiments were part of an ongoing research programme leading up to studies at pack and system level. The responses of the cells to the various forms of abuse were monitored with optical and thermal cameras, thermocouples and by measuring cell voltage. Draeger gas sensors were also employed where possible. The nail penetration experiments were carried out at (nominally) 96.5%, 75% and 50% SOC, and at 96.5% SOC as a function of penetration location: the experiments strongly suggest that low SOC is as hazardous as high SOC, in contrast to a general perception in the literature, as the likely hazards ar

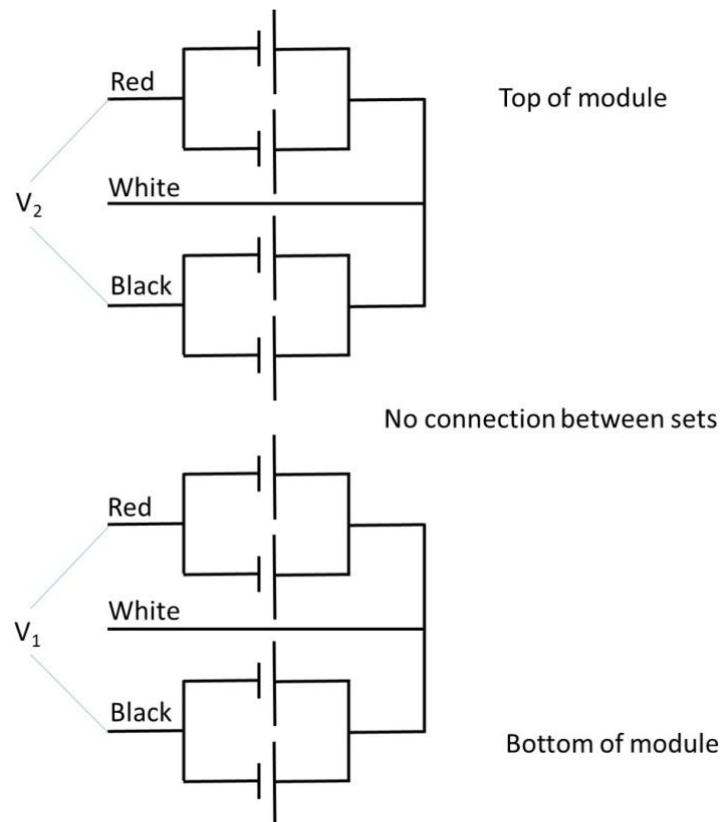
Figure 1. Schematic showing the wiring of the modules and the cell voltages monitored during the experiments at the DNV GL site.

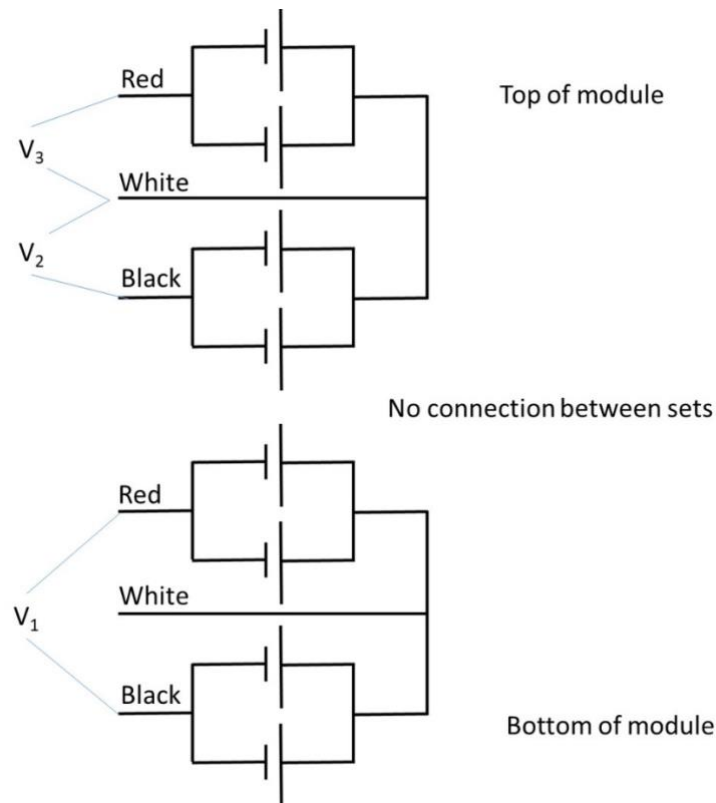
Figure 2. Schematic showing the wiring of the modules and the cell voltages monitored during the experiments at the FSC.

Two penetration experiments at 50% SOC and 75% SOC were conducted at the Fire Services College (FSC), with penetration at the top middle, between the tabs, as in experiment 2 at the DNV GL site. To guarantee the module being penetrated was at a certain SOC level, the constant current constant voltage protocol (CCCV) was applied using a HCP-1005 potentiostat from Bio-logic. During the experiments, the voltages of the penetrated modules were monitored as shown in Figure 2.

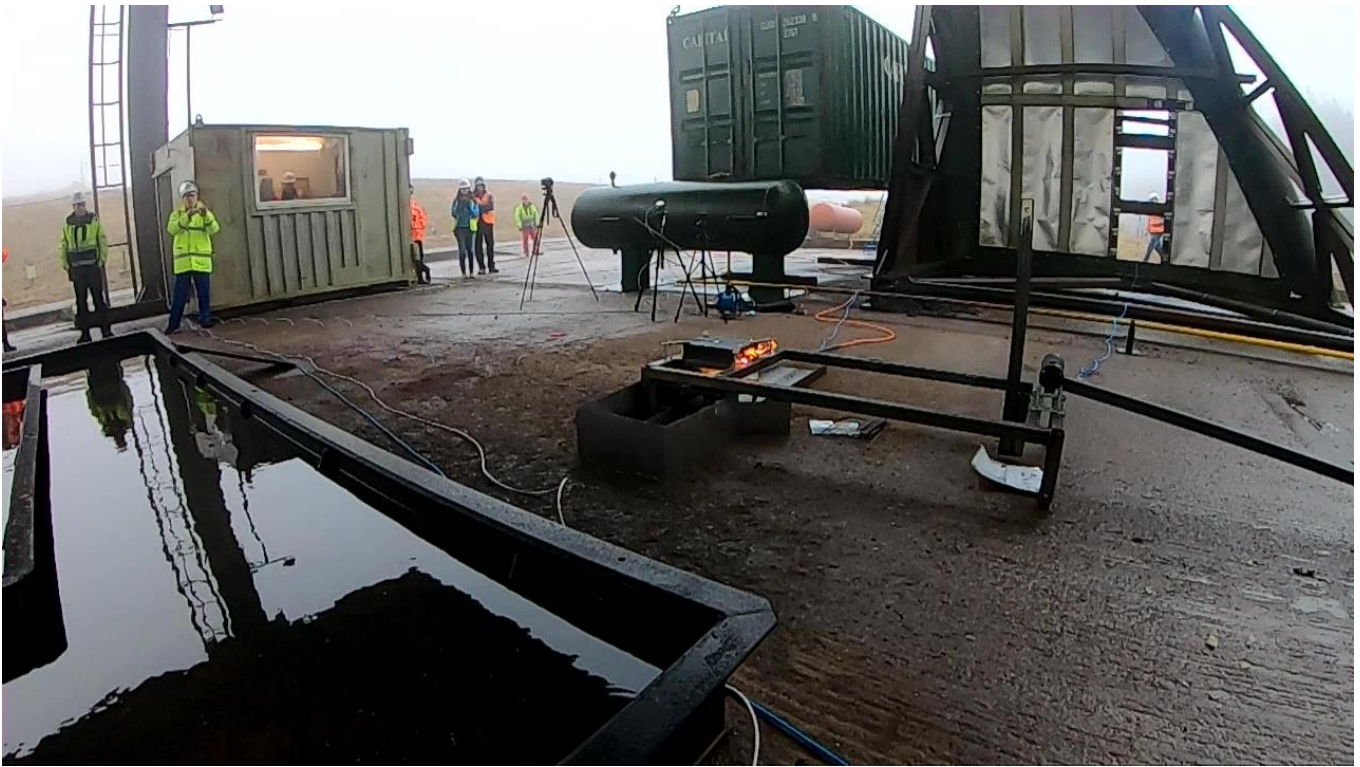
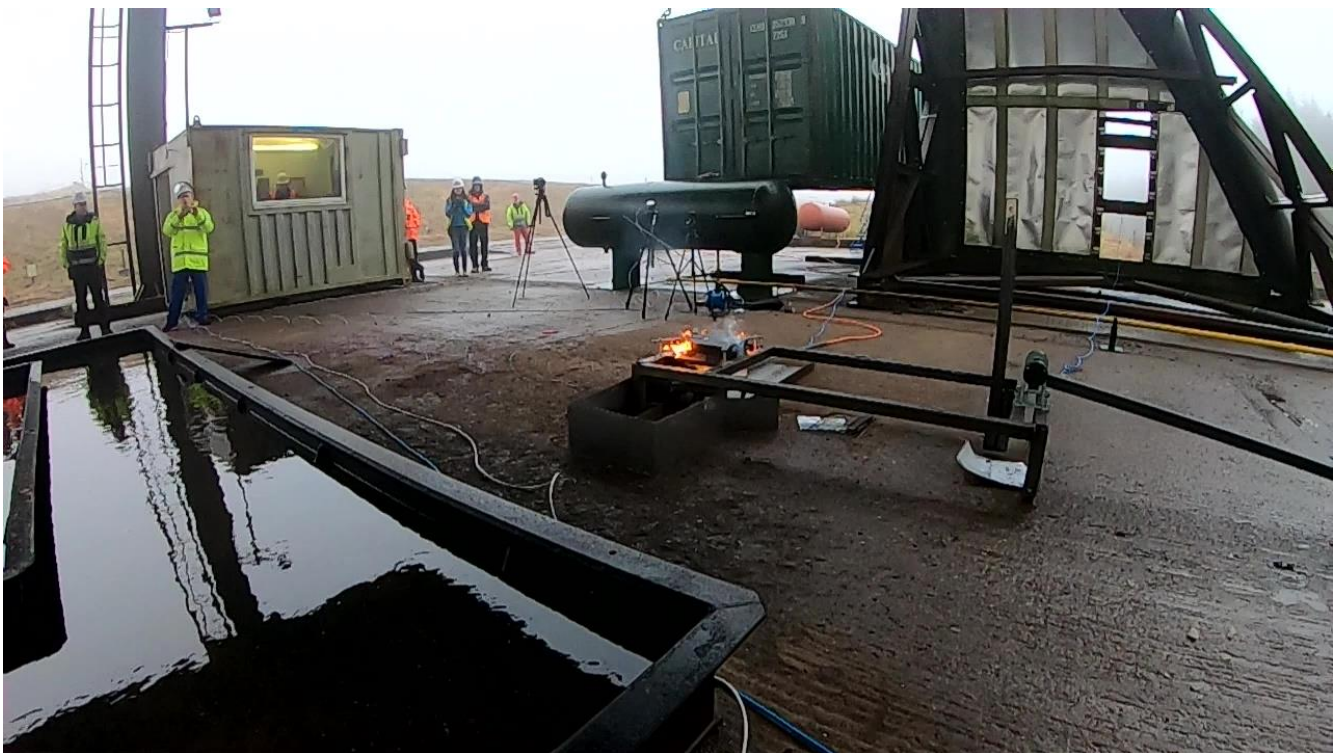
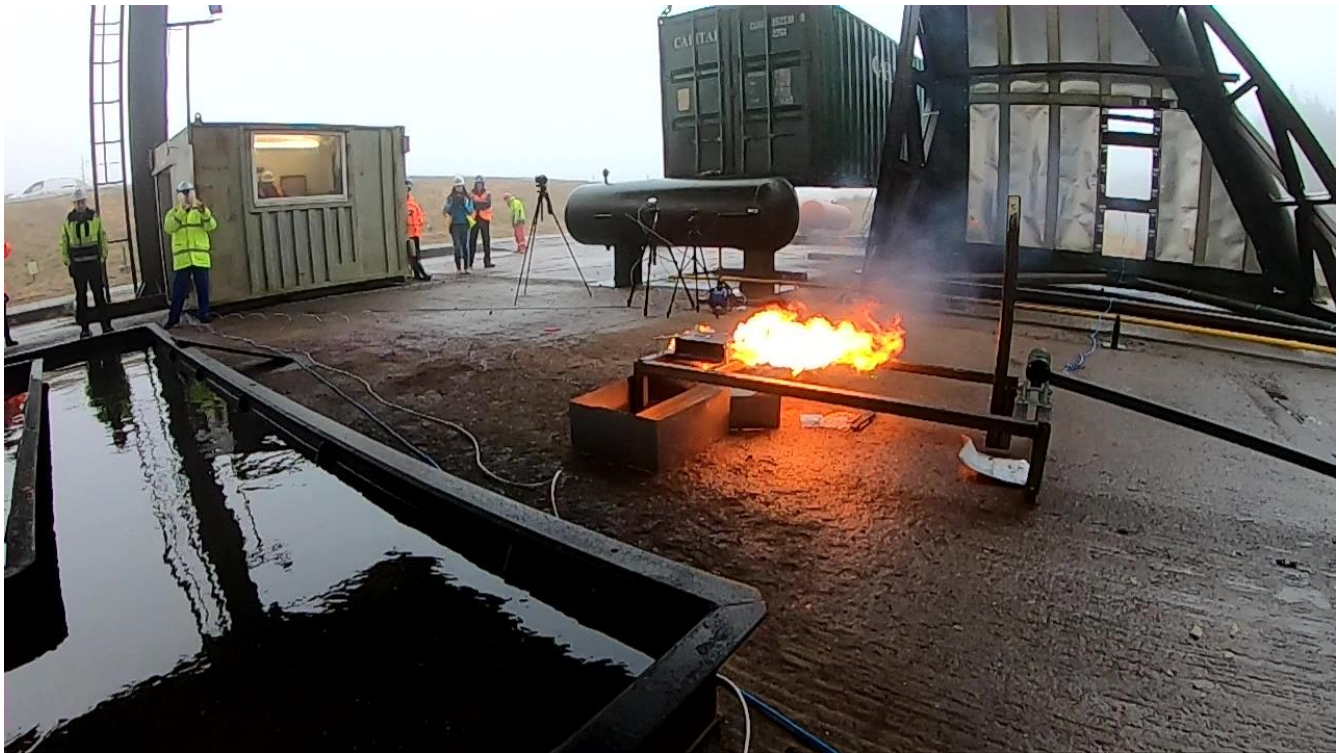
Figure 3. Stills from the video images: (a) 70s, (b) 73s and (c) 130s from the start of the first experiment at the DNV GL site.

Stills from the video camera located in front of the module are shown in Figures 3(a) – (c). The burner was moved under the module 27 s into the experiment (i.e. 27 s from when the GoPro cameras were switched on). Smoke was observed 70 s into the experiment (Figure 3(a)), followed by small flames 73 s in (Figure 3(b)). After 106 s the burner was removed and 130 s from the start, flare-like flames were observed to issue from the modules on the side opposite to the connectors (Figure 3(c)), as expected, as the pouch cells are designed to vent from the bottom of the cell (i.e. furthest away from the tabs) on ignition.

The flames visible in Figure 3(a) were external to the module and were due to the burner. In (b), flames began to be generated from the module in addition to the burner. In (c), with the burner completely removed, all flames were being generated from the module itself and flare-like flames were observed from the module, with flame lengths as shown in Figure 4: the latter shows six spikes due to flares: i.e. less clearly defined than the flame areas in Figure 5(a).

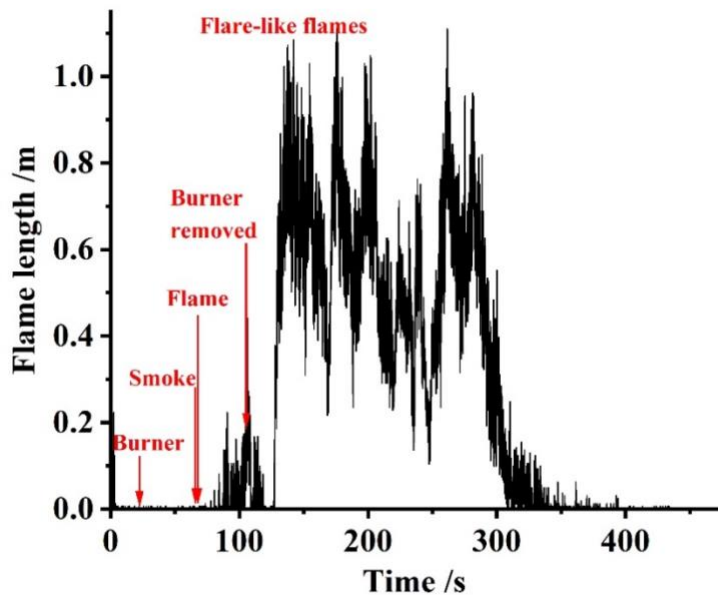
Figure 4. Flame lengths calculated from the burner experiment, experiment 1, at the DNV GL site. See text for details.

The sequential loss of the cells can be seen in the plots of flame lengths calculated using the images from the two GoPro cameras, see Figure 4, and more clearly in the plots of flame areas in Figure 5(a) where 7 separate peaks were observed in a span of 3 minutes, suggesting distinct thermal propagation between the cells at each peak.

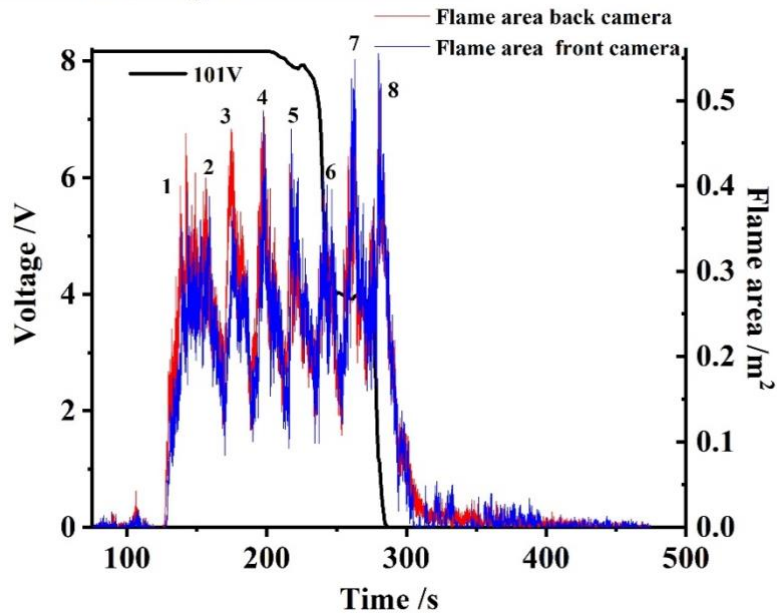
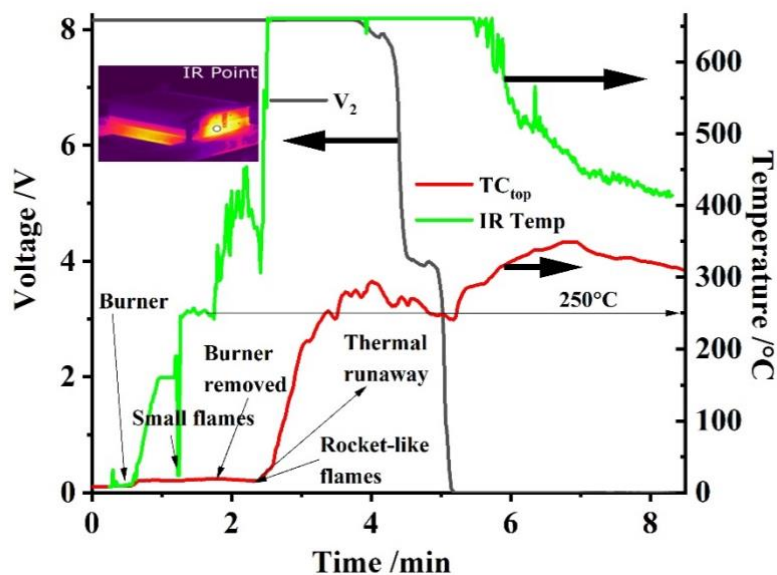
Figure 5. The DAQ and thermal camera data recorded during the burner experiment, experiment 1, at the DNV GL site and the flame areas calculated from the optical videos. The location employed for thermal camera temperature is shown on the inset. (a) cell voltage and flame areas, and (b) cell voltage, thermocouple and thermal imaging data.

the flame areas calculated from the image processing of the optical images taken by the GoPro cameras. As can be seen from Figure 5(b), the IR temperature increased immediately as the burner was moved beneath

the module, rising steadily until ca. 2.42 minutes after which it increases very rapidly (at ca. $98\text{ }^{\circ}\text{C s}^{-1}$) signalling thermal runaway. The camera was calibrated to operate over the ranges -40 to 150°C and 100 to 650°C , and hence flatlined when the temperature reached the top of its range: subsequently, the temperature recorded by the thermal camera decreased after ca. 6 minutes to ca. $400\text{ }^{\circ}\text{C}$, and this coincided with a lack of flames around the region monitored. The thermocouple temperature lagged behind that of the IR by ca. 2 minutes, showing little or no increase until ignition occurred and the production of the flare-like flame, after which it increased to ca. 275°C for ca. 1 minute before increasing again to $300 - 350\text{ }^{\circ}\text{C}$: the unstable nature of the response reflecting the influence of the flames. From Figures 5(a) and (b) it can be seen that the voltages of the top two parallel pairs of cells in the module collapsed in two clear steps once the temperature on the top face of the module reached ca. $275\text{ }^{\circ}\text{C}$ (unfortunately, the monitoring of the output voltage from the lower quartet of cells failed): these steps are clear in Figure S9 which shows the first derivative of the voltage: the voltage collapsed rapidly (ca. 42 and 55 V min^{-1}) in both steps. The temperature registered by

As can be seen from Figure 5(b), the module remained hot after the last cell ignition and it was generally observed that the module carcasses remained at temperatures significantly above 300 °C for over 40 minutes after the fires had ceased, and hence were still potential ignition sources.

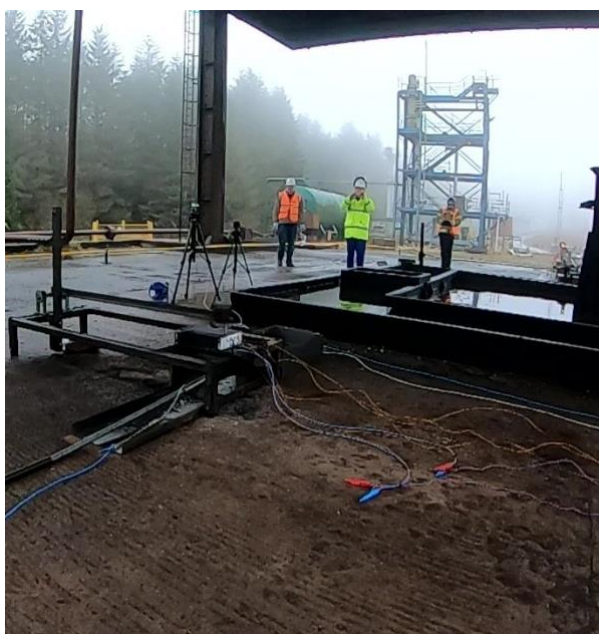
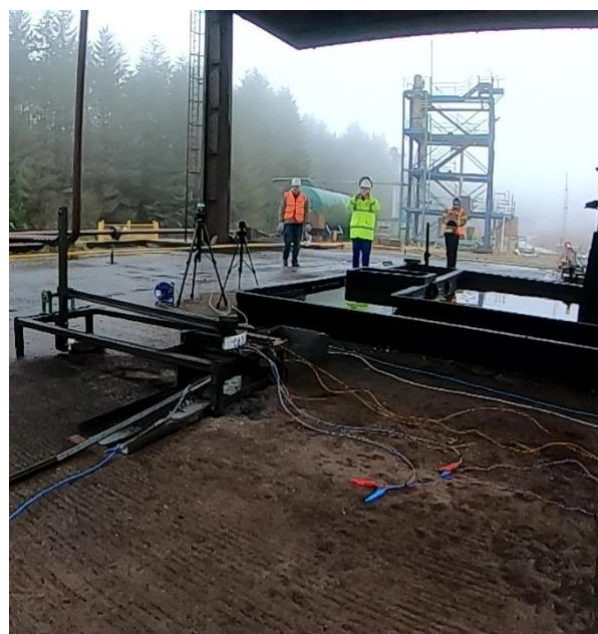
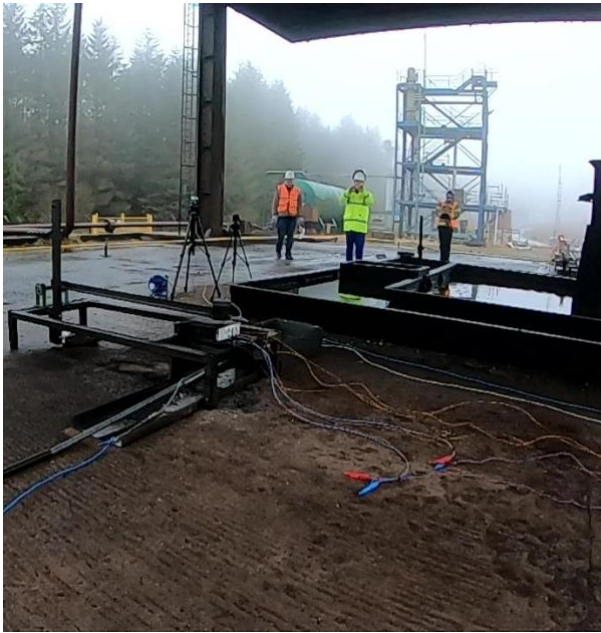
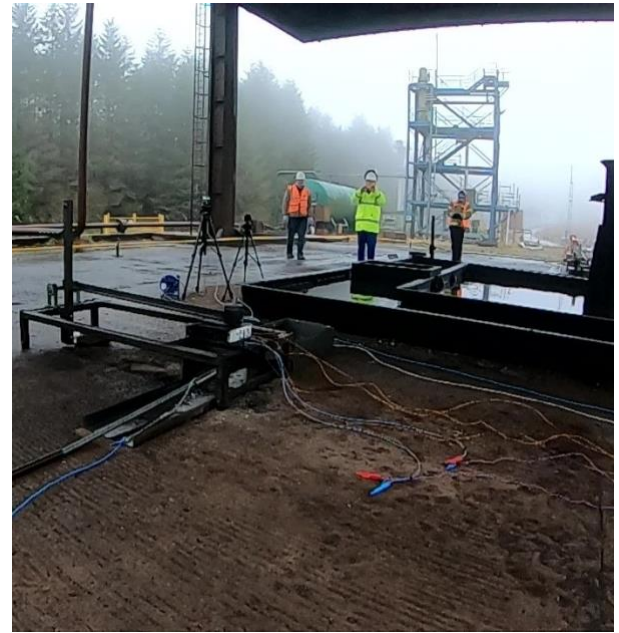
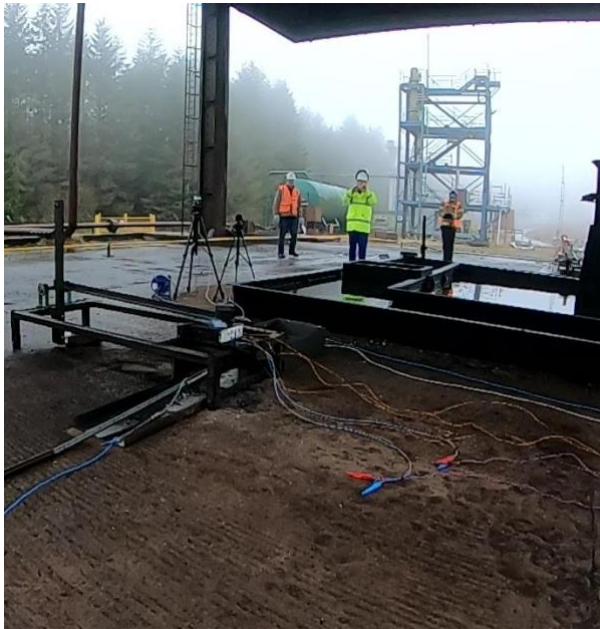
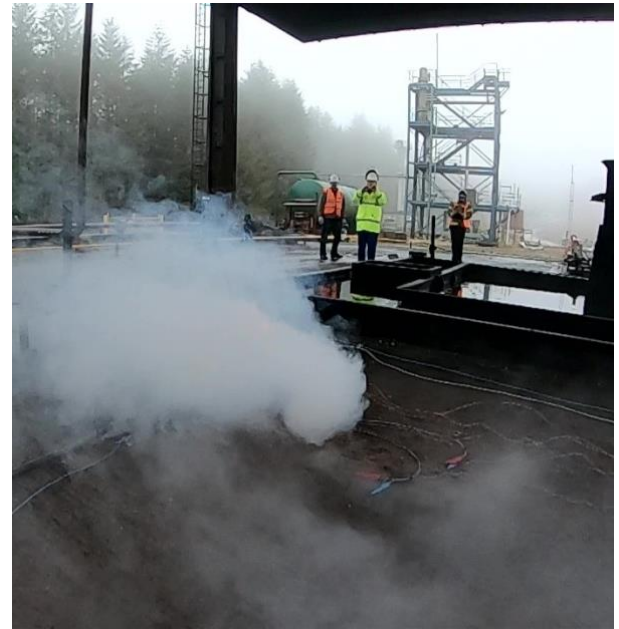
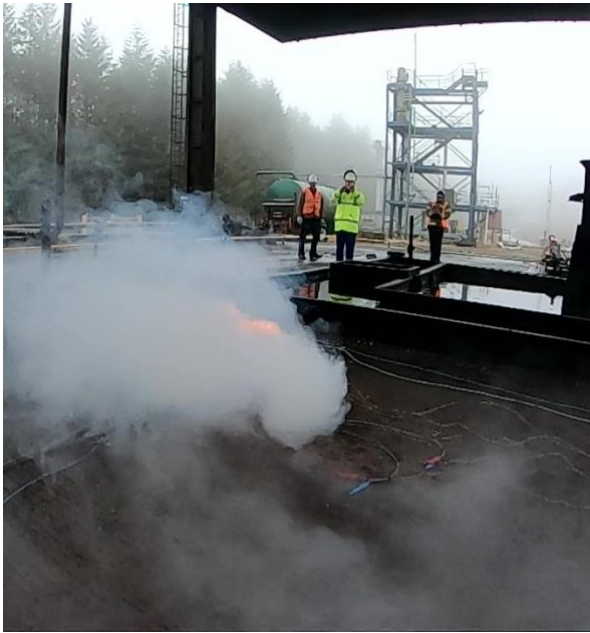
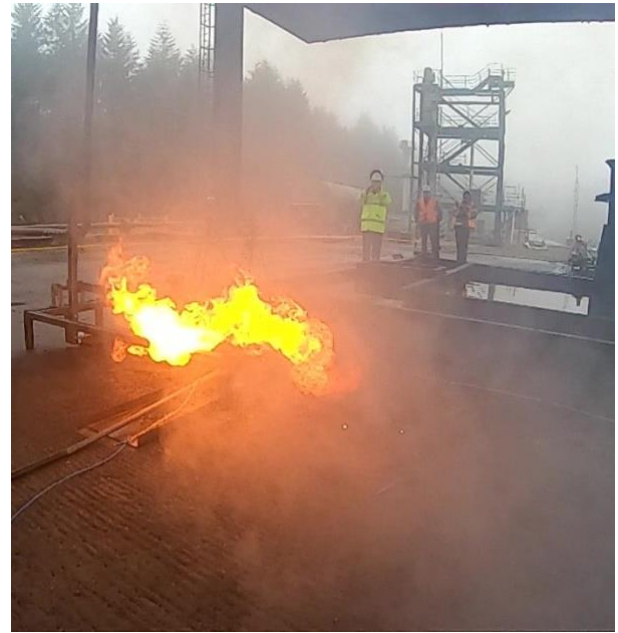
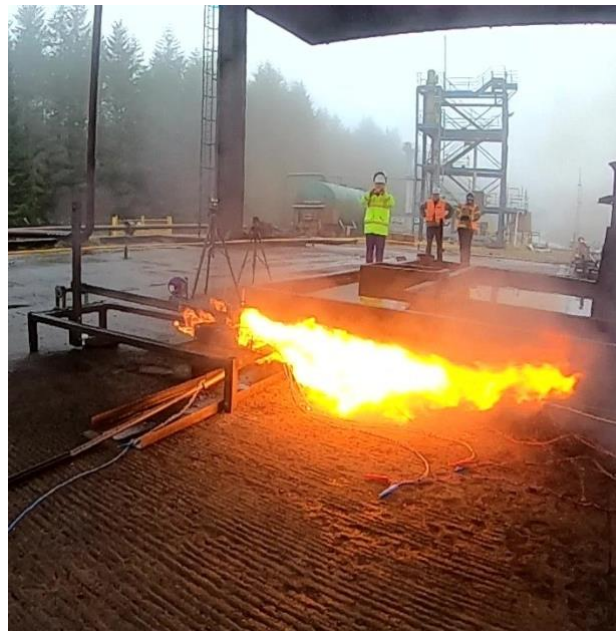
Figure 6. Stills from the GoPro videos taken during experiment 2 at the DNV GL site: taken (a) at nail piercing and (b) – (e) 4.17ms, 16.68ms, 66.72 ms and 233.52 ms after penetration. Figures (f) – (i) were taken 0.54s, 9.50s, 13.42 and 18.05s, respectively, after the image taken in (e).

The subsequent images in the figure highlight the stages generally observed during all the abuse experiments performed on the Envision-AESC modules, as well as reflecting the literature of LiB abuse experiments in general. Thus: Figures 6(e)-(g) the initial evolution of dense, white vapour starting with a wisp immediately after penetration, then (g) & (h) ignition of the vapour to produce much thinner fumes, followed by (i) flare-like flames. Once all the electrical energy was expended, the fire resembled that from burning plastic with smoky flames and thin black smoke.

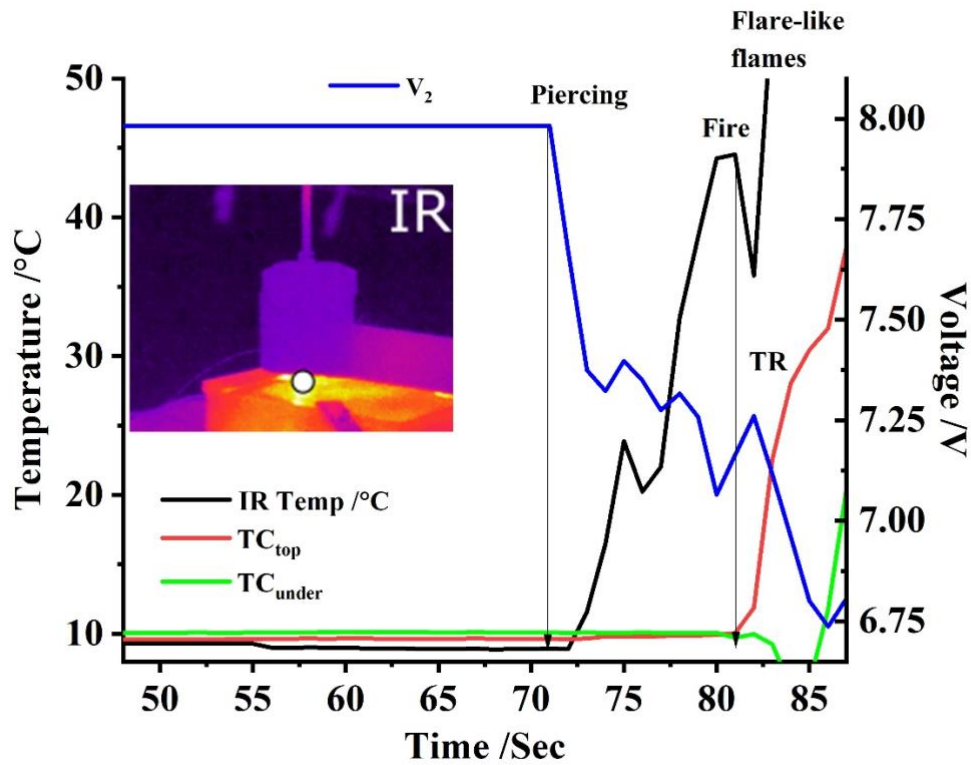
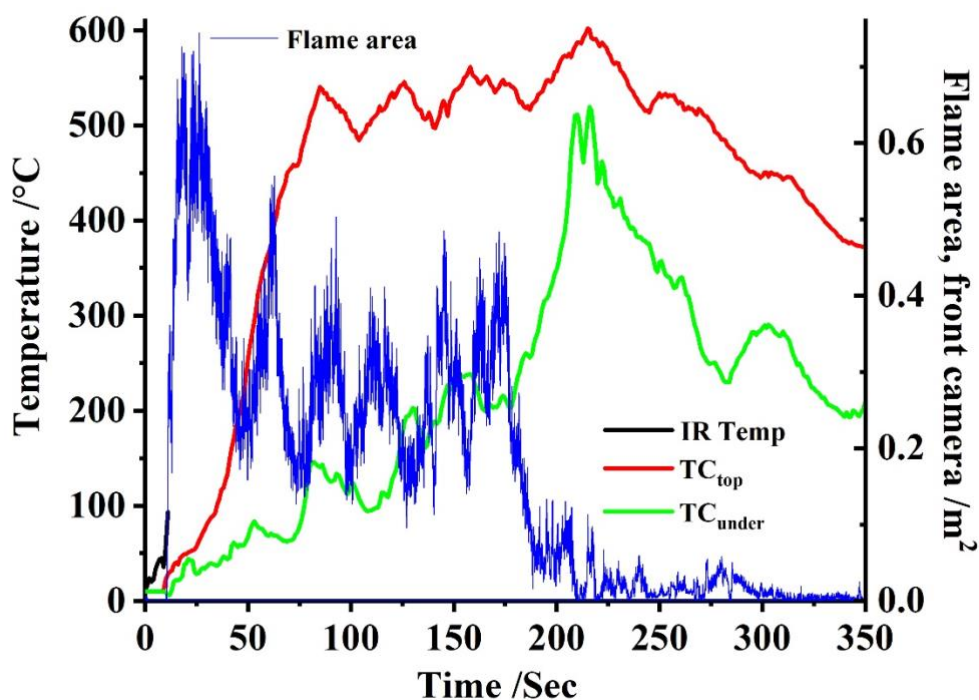
Figure 7. The DAQ and thermal imaging data collected during the nail piercing experiment 2 at the DNV GL site, and the flame areas calculated from the front optical camera. (a) Up to thermal runaway: (b) and (c) all data. (b) Flames areas, thermocouple and thermal imaging data and (c) cell voltage and flame areas.

The voltage of the top quartet of cells collapsed immediately, see Figure 7(b), and in a single step after penetration at ca. 50 V min^{-1} from 8V to ca. 0.6V as the temperature reached ca. $324 \text{ }^\circ\text{C}$. However, and very surprisingly, the voltage then recovered to ca. 6.3V at 168 V min^{-1} before increasing more slowly to 7.8V before decreasing again as the temperature on the top face of the module reached $420 \text{ }^\circ\text{C}$: this collapse was in two stages, again reflecting the sequential failure of the parallel pairs of cells. The first step tracked that of the lower quartet of cells, and occurred at ca. 50 V min^{-1} . The remaining two parallel cells of the top quartet then decreased faster (100 V min^{-1} c.f.f. 24 V min^{-1}) and 36 s earlier than the remaining parallel cells in the lower quartet. The varying thermocouple responses reflect the effect of the flames licking around them.

Figures 7(b) and (c) show the flame areas calculated from the front video camera data (the rear camera failed to record): as can be seen, the ignition of the various cells is shown by the various flame area peaks, where the flame areas drop after the initial peaks from the ignition of a new cell, and then spike to a peak again when the next cell ignites. From the figures, it is clear that the magnitude of the maximum flame areas varied between ca. 0.4 - 0.7 m², at each cell ignition. As the last cell ignited, the flame area quickly reduced as the remaining flames were simply due to the remaining burning plastic.

In terms of the failure of individual cells, Figure 7(c) suggests that the cells fail as in the order shown in Figure S11.

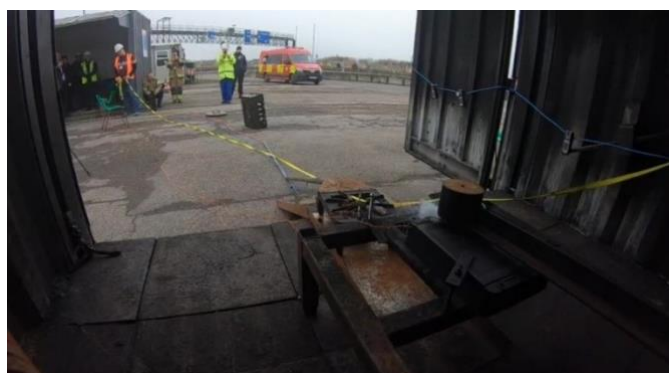
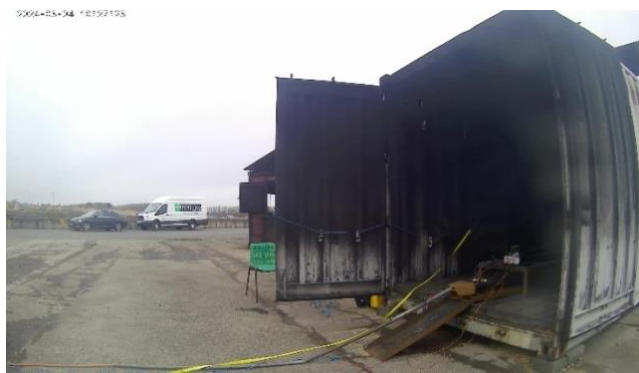
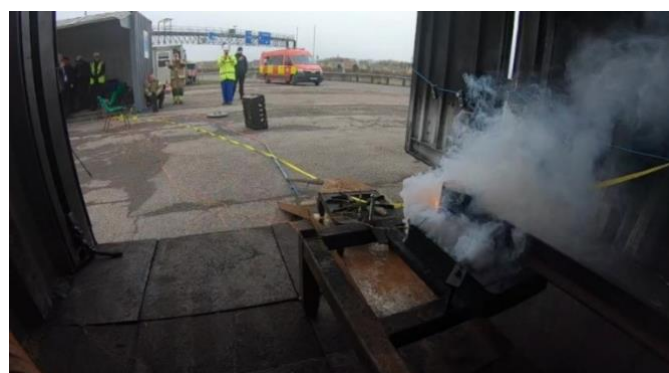
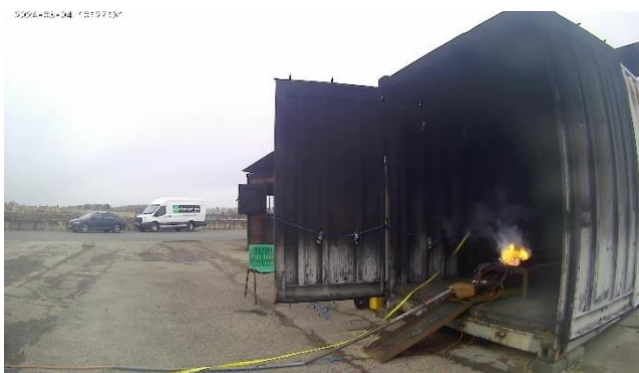
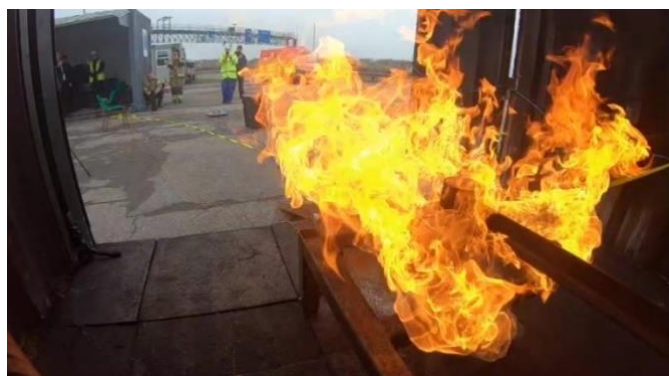
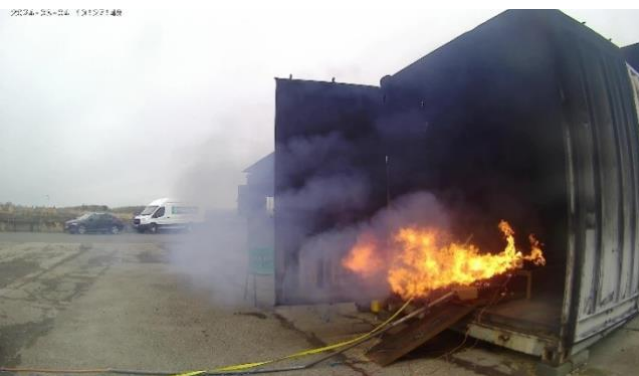
Figure 8. Images taken during experiment 1 at the FSC (nail penetration at 75% SOC): (a) 0.532s, (b) 0.538s, (c) 3.794s, (d) 3.858s, (e) 10.567s and (f) 82.6s after nail penetration.

The first experiment at the Fire Services College was a nail penetration between the tabs, identical to experiment 2 at the DNV GL site except the module was charged to c. a. 4.03V, i.e. 75% SOC. The same sequence of events were observed as in the DNV GL experiment, see Figures 8(a) – (f): a wisp of white vapour as soon as the nail penetrated 0.532 s (a) and 0.538 s (b), then the evolution of thick white vapour followed by (in this case) the almost immediate ignition of the vapour 3.794 s (c) and 3.858 s (d), then flare-like flames from the front, side and rear of the module (e) 100.567 s (e) and 82.6 s (f) after penetration.

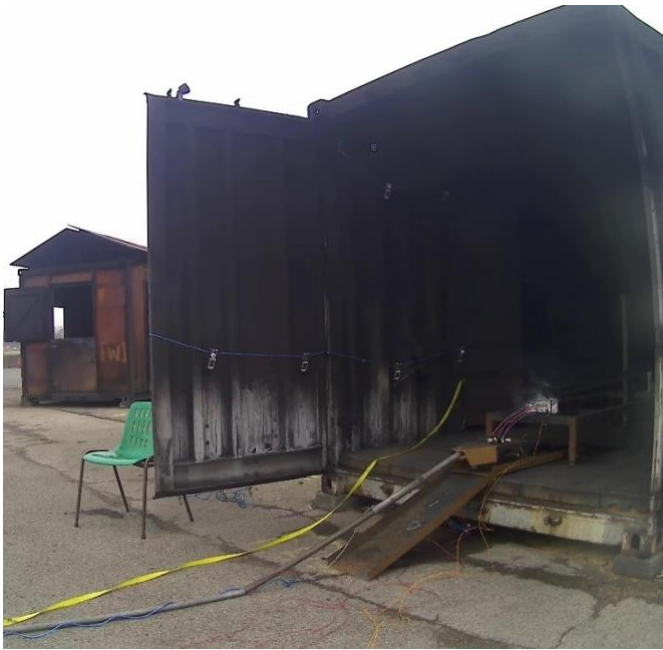
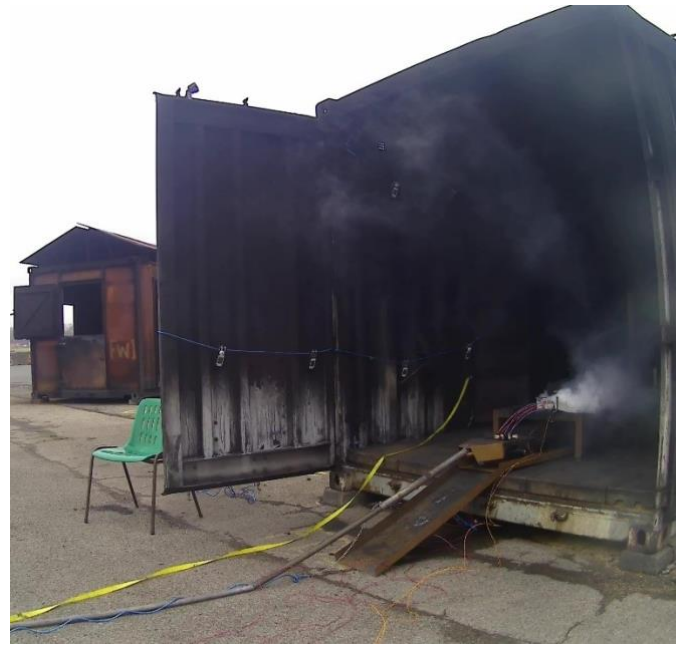
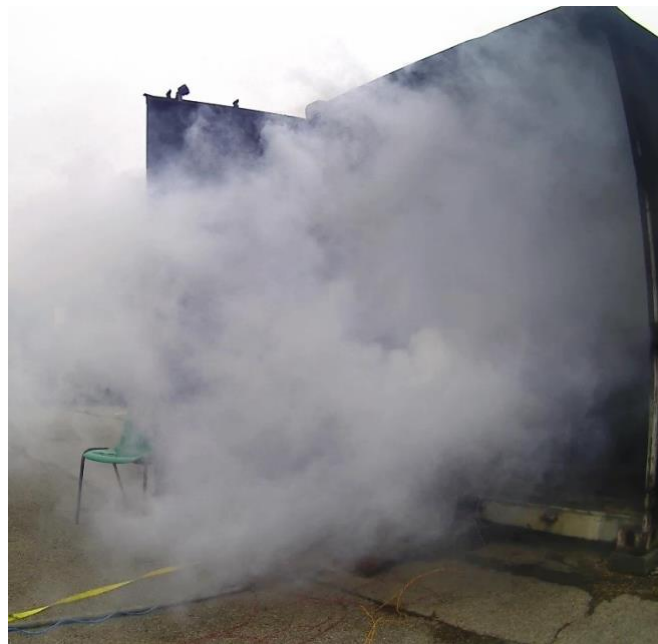
Figure 9. Stills from the video taken of experiment 2 at the Fire Services College: nail penetration at 50% SOC. Image (a) was taken 26.47 s after the nail penetrated the module completely; (b) was 35.47 s after penetration and (c) 52.13 s after penetration.

Figures 9(a) – (c) show stills from the video taken of the experiment: (a) was 26.47 s after the nail penetrated the module; (b) was 35.47 s after penetration and (c) 52.13 s after. The white vapour did not ignite during the experiment and, as can be seen from the figure, was clearly heavier than air, rolling across the ground, pushed by the slight breeze running from right to left in the images.

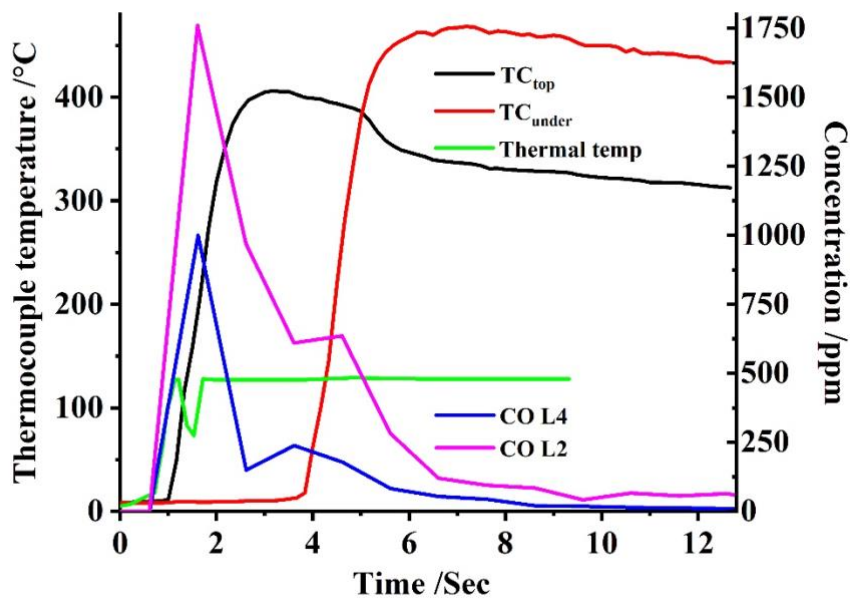
Figure 10. (a) and (b) plots of the concentrations of the various gases detected during experiment 2 at the Fire Services College and the thermocouple and thermal camera temperatures, (a) CO and (b) HCl/HF* and SO₂. Concentrations of (c) CO & SO₂ and (d) NO₂/HCN* observed during the experiment. * See text for details.

Figures 10(a) - (d) show plots of the gas sensor, thermocouple and thermal readings taken during the experiment.

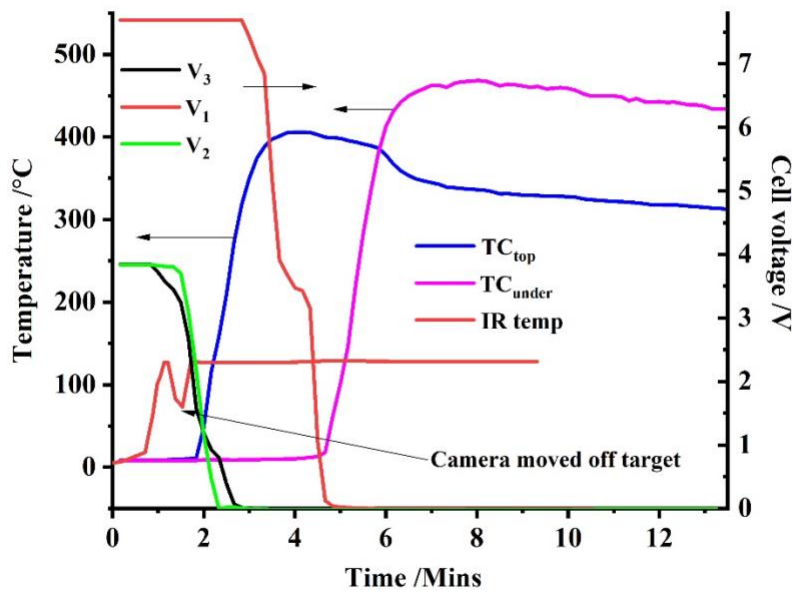
Figure 11. The DAQ data collected during the nail piercing experiment 2 at the FSC site and the temperature recorded by the thermal camera.

Figure 11 shows plots of the thermocouple temperatures and cell voltages observed during the experiment. In contrast to the experiments where the vapour ignited causing the thermocouple readings to fluctuate due to the flames, the first derivatives of the thermocouple readings from experiment 2 at the College showed a homologous response, see Figure S12 with a single, well-defined maximum for each thermocouple.

As can be seen from the figure, despite the fact that the nail penetrated all the cells, whilst the voltages of the top four cells collapsed fairly soon after penetration, the lower four cells retained their charge for ca. 2 minutes.

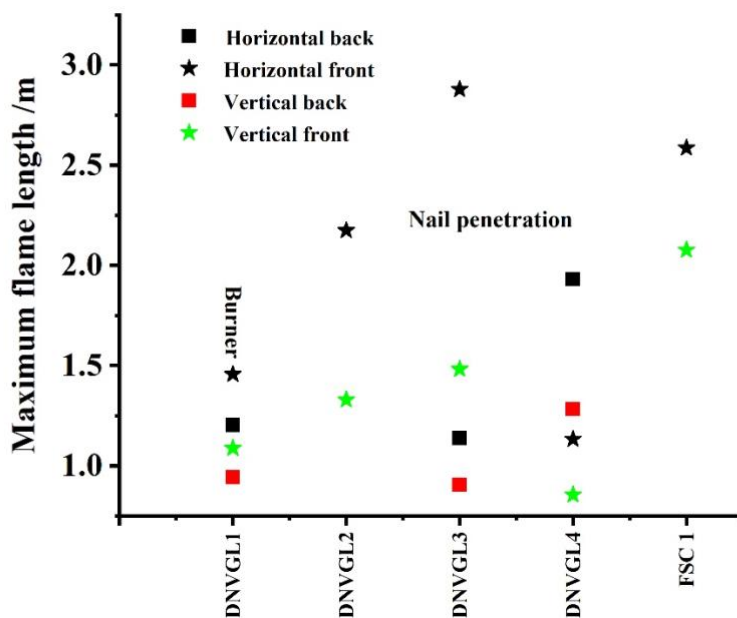
Figure 12. Maximum vertical and horizontal flame lengths measured in DNV GLS experiments 1 - 4 and FSC experiment 1.

different, hence affecting the flame lengths. The maximum vertical and horizontal flame lengths measured via image processing in each experiment are shown in Figure 12. Experiments 2, 3 and 4, all nail penetration experiments but with penetration at different points on the modules, showed different maximum flame lengths, with a maximum flame of 217 cm observed.

It can be seen from Figure 12 that the maximum flame length was observed in experiment 1 at the FSC (75% SOC, nail penetration). The maximum flame length measured was 275 cm, which is ca. 9 times the length of the module itself. Hence, careful consideration must be made in safety designs to account for safety distance, as from these observations any flammable material or mixture up to 275 cm from the pack could receive intense and rapid heating rates from these flares in the case of a module failure.

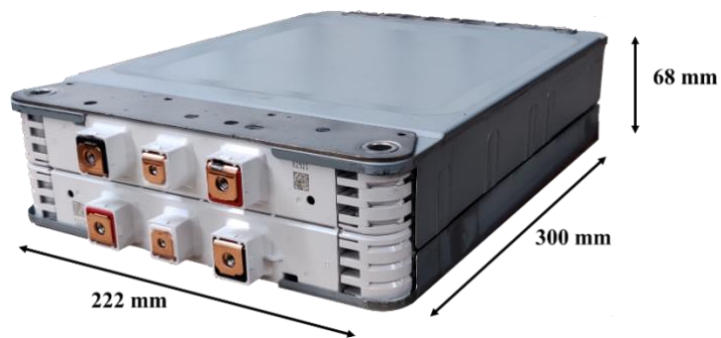
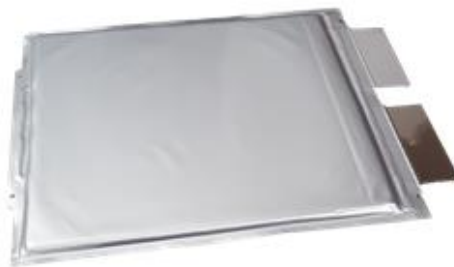
Figure S1. (a) The 8-cell module, (b) a pouch cell and (c) the wiring of the cells within the modules: the cells are arranged in two units of four cells with no connection between the units.

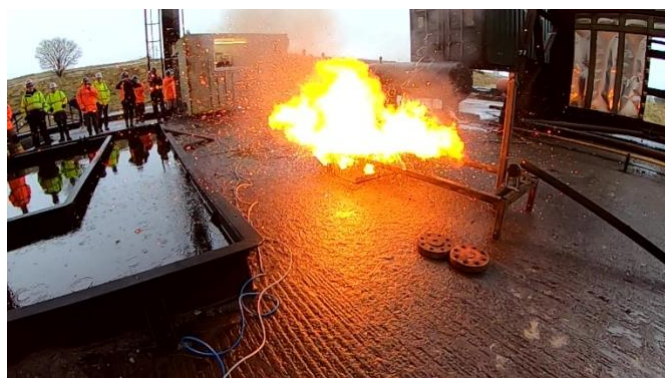
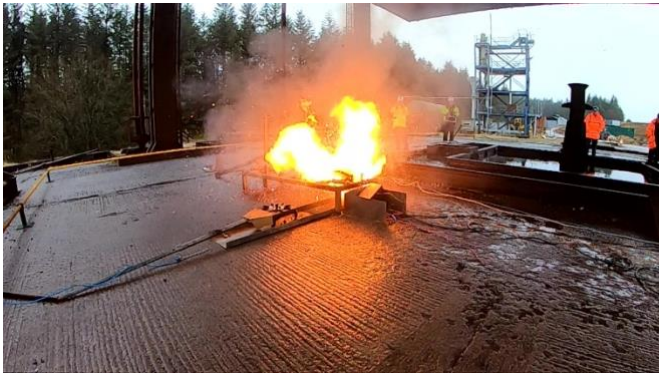
For the flame length and area analyses, each optical image was converted into white/black pixels based on the presence of flame vs lack of flame. Figure S4 shows data from DNV GLS experiment two as an example of the image processing of the stills for calculations of flame length and areas from both the front and back cameras. As can be seen from the images, the processing clearly identifies the flames while keeping the battery pack a fixed black colour (centre of images in (b) and (d)) and removes effects from reflections, as can be seen by comparing the images in (c) and (d).

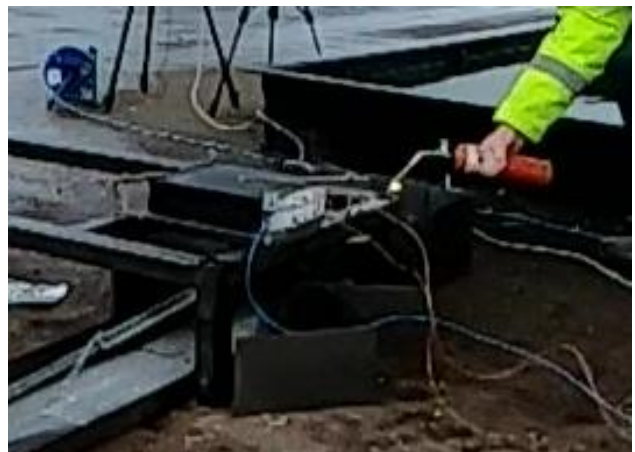
Figure S5. Thermal image showing the lighting of the burner being lit at RAFS. Figure S6: The optical image equivalent of figure S5.

With multiple data sets, a common start time is difficult to identify. To achieve this, the frames of the thermal videos were extracted using VLC and a significant event selected, e.g. burner ignition see Figure S5. The corresponding frame from the optical images was then identified and selected, see Figure S6, and hence the timing of the images could then be correlated in absolute terms.

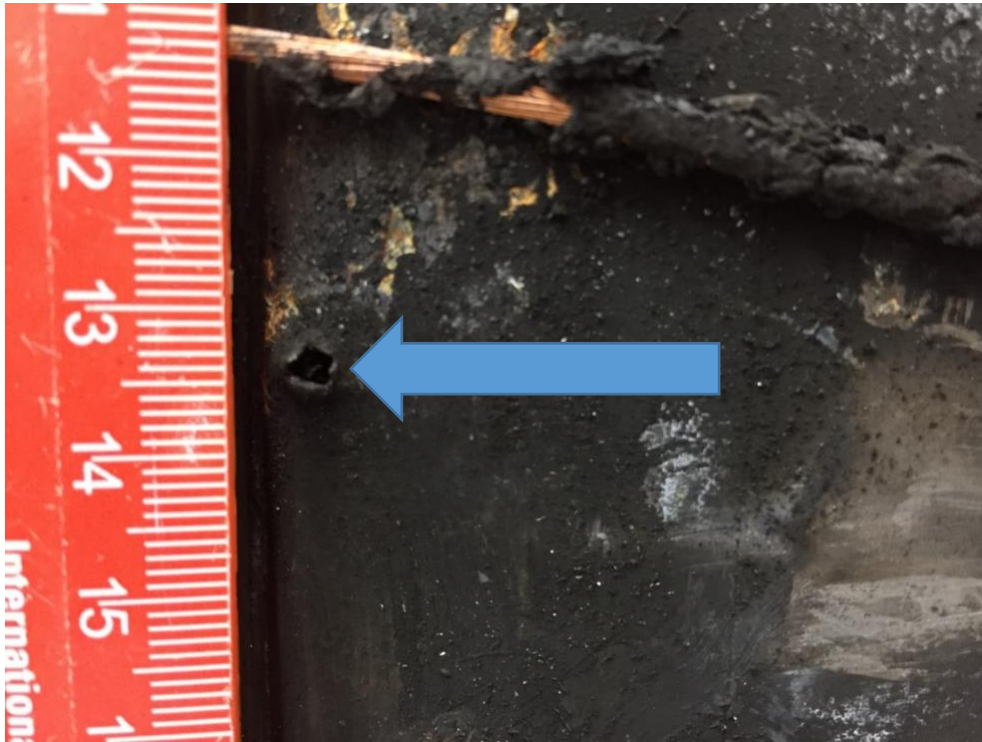
Figure S10. Photograph of the underside of the module employed in experiment 2 at the DNV GL site showing the exit hole (arrowed) of the nail.
